CONSEIL SECURITE
CIRCULAIRE DE SECURITE N° 197

Réf.: 20.0776

Objet: remise à hauteur du système de libération des parachutes tandem fabriqué aux USA

Product Service Bulletin

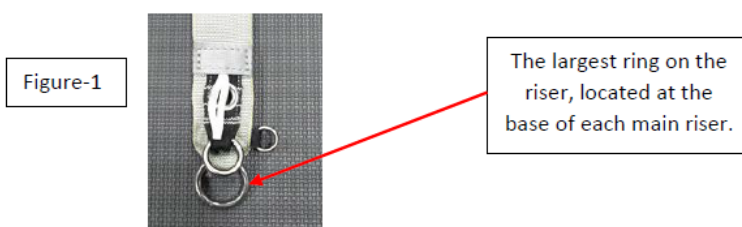
Identification: After-market Tandem Main Risers constructed with obsolete RW2 rings. All sport tandem main risers produced with RW2 rings, or equivalent sized rings, are affected regardless of the hardware manufacturer, the date of manufacture, the material type or the forging process used. This PSB does not affect "solo" main risers that use RW2 rings.

Background: Recent reports of "bent rings" on tandem main risers are of great concern. At least one after-market manufacturer of obsolete and unapproved tandem risers is using RW2 rings or similar rings, which were discontinued for tandem use in 1996 due to "bent ring" issues. These rings pass a proof load of 500 lbs. and begin to distort at 2500 lbs.

Two (2) sets of tandem risers were recently discovered with bent rings. This pair bent after one (1) jump; a second pair had approximately 30 jumps.

Compliance: **MANDATORY** – REPLACE BEFORE THE NEXT JUMP.

RW2 rings (or similar size rings) have a cross-section thickness of less than 5mm (0.197"). Risers with these dimensions should be permanently grounded for tandem use.
