CIRCULAIRE DE SÉCURITÉ N° 186

Objet: Rappel pour échange de certains sectionneurs et contrôle de certains autres des appareils VIGIL. **Remplace la C.S. n° 185.**

EMERGENCY PRODUCT SERVICE BULLETIN
(Supersedes Product Service Bulletin PSB-7)

Bulletin Number : PSB-8

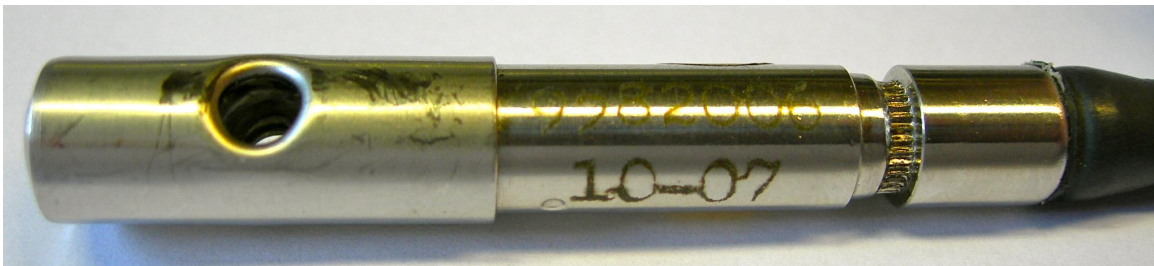
Photo 1

Vigil AAD, All Cutters produced in October 2007
Part Number: 9582006
Date of Manufacture: 10-07 (mm-yy)
(See Photo 1.)

The cutter was part of a production batch of 299 pieces, produced in October 2007. (See Photo 1.) In the interest of safety, AAD has decided to recall all cutters from the October 2007 cutter batch and to replace all of those cutters free of charge. The removed cutter must be returned to AAD sa/nv or Vigil USA, LLC once the replacement cutter has been received. (Please contact AAD sa/nv or Vigil USA, LLC for return information and instructions.) This will enable us to personally examine and analyze as many cutters as possible from this batch in order to verify that this, in fact, has been an isolated incident.

DOM : October 2007

Dépose et renvoi immédiat au constructeur de tous les sectionneurs datés 10/07.

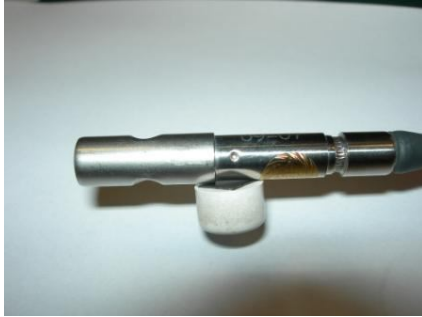
In the interest of additional safety, we have devised a field test, which can be performed on any Vigil cutter, using a magnet to confirm the presence or lack of a knife blade. It can be done using any magnet on any cutter. Either a small (see Photo 2A) or a larger (see Photo 2B) magnet may be used. You must ensure that the magnet is placed directly below the closing loop hole portion of the cutter, as shown in Photos 2A and 2B. If there is a knife blade present, the magnet will be attracted to the knife blade. If you require a magnet they are available on request from AAD sa/nv or Vigil USA, LLC.

Photo 2
Magnet Test Procedure

Note: All Cutters manufactured from June 2008 have been x-rayed as part of our quality control process, and we have confirmed that the knife blade is present, however for additional safety, we highly recommend that the magnet test be performed on each cutter manufactured prior to June 2008.

Once compliance with this bulletin has been met, and, if necessary, the 10-07 cutter has been replaced, or a cutter with a manufacture date prior to 06-08 has been tested with a magnet and it has been determined that a cutter is present, or it has been determined that the cutter DOM is 06-08 or later, the reserve parachute packing data card should be marked with "Vigil SB-8 - OK."
