## SB #35 Tandem Drogue Bridle 3-Ring Attachment Inspection

**BULLETIN NUMBER:** SB #35

**SUBJECT:** Tandem Drogue Bridle 3-Ring Attachment Inspection

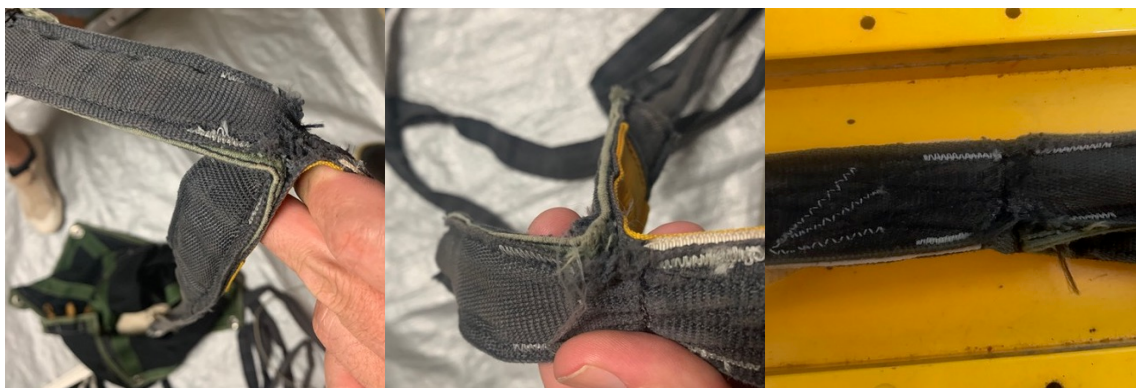
**BACKGROUND:** Affected Drogues included an engineering change to the stitching junction at the 3-Ring end of the Drogue Bridle using one continuous piece of webbing. While the new configuration performed well during initial testing, End-Users in the field reported accelerated and excessive wear in this location.

**SERVICE BULLETIN:** All affected Drogues must be grounded until the 3-Ring attachment end of the Drogue Bridle is carefully inspected for accelerated excessive wear. The photos below show a Drogue that was removed from service after approximately 200 jumps and shows excessive wear. While these are not objective parameters, they may be used to guide the Inspector's subjective decision to continue use with subsequent inspection after each jump or remove the Drogue from service. If there is any doubt, remove the Drogue from service.

Drogues removed from service must be returned to Strong Enterprises for rework.
